Irradiation Treatment of Laryngeal Cancer in a Patient with an Implantable Cardioverter-Defibrillator (ICD)

Susanna Sepe Pamela Schaffer Klaus Krimmel Moshe Schaffer

Klinik und Poliklinik für Strahlentherapie und Radioonkologie, Ludwig-Maximilians-Universität München, Germany

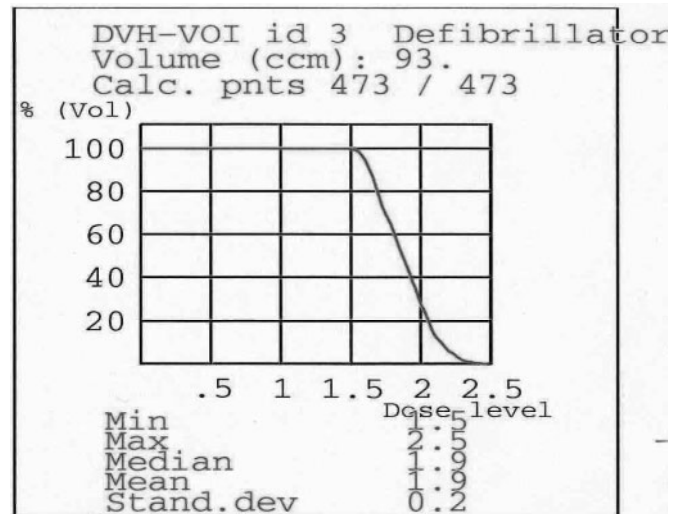
We created a 3D multifield plan. An added dose-volume histogram (DVH) was created for the ICD (fig. 1). Despite all efforts it was impossible to reduce the expected radiation to the ICD to less than a cumulative dose of 2.5 Gy due to the close proximity to the tumor region. Irradiation was administered conventionally 5 days a week with a multileaf linear accelerator and 6 MV photons from January 2005 until March 2005. A 4-field technique was applied. The extended tumor and lymphatic regions were irradiated up to 36 Gy. Subsequently, we used a preserving technique for the spinal cord for an additional dose of 14 Gy. Only the former tumor region was further treated with single doses of 2.0 Gy up to a dose of 10.0 Gy. A cumulative dose of 60.0 Gy was achieved.

Fig. 1. The pretreatment added dose distribution shows that the defibrillator received a maximum dose of 2.5 Gy. DVH = Dose-volume histogram.

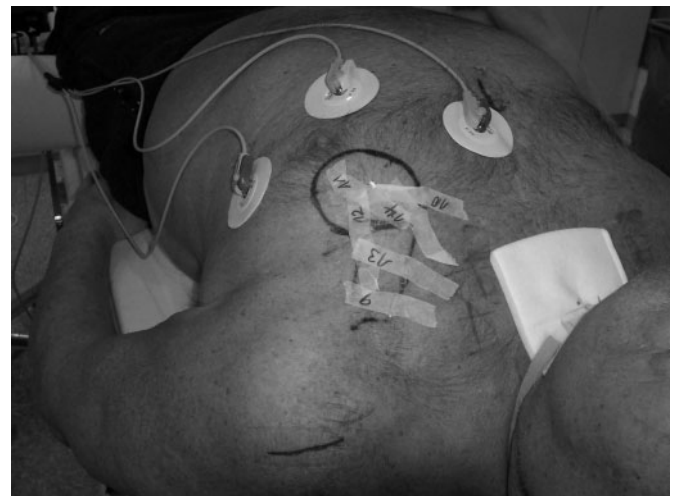
Fig. 2. The implantable cardioverter-defibrillator is under the marked circle. The numbers show the thermoluminescence dosimeters. The field margin from the lymphatic region reaches approximately to the lower margin of the tracheal bandage.

It was possible to administer the radiation therapy without interruption or complications. 5 cGy scattered radiation was measured in the center of the ICD for one irradiation treatment. 9 cGy was measured on the ventral and lateral margin of the ICD. The second measurement after field reduction showed 3 cGy centrally. The margins demonstrated ranges between 5 and 7 cGy. In total, this resulted in a cumulative dose of 2.5 Gy on the ICD for the whole treatment period. The measured TL doses corresponded with the DVH calculated before starting treatment. All cardiologic examinations demonstrated a regular function of the ICD. At the final cardiologic examination, ventricular fibrillation was intentionally induced. The ICD terminated the dysfunction through internal shock with regular charging time. The battery status was in order.

We placed a magnet measuring 2.0 × 5.0 cm onto the ICD for deactivating the device directly prior to the irradiation sessions. The patient was connected to an ECG unit, which was monitored from the control room. A radiation oncologist was present at all times in case of an emergency to remove the magnet from the ICD. This step could reactivate the ICD. On the first day of radiation therapy we performed thermoluminescence (TL) measurements in order to control for scattered radiation in vivo. Single dosimeters were grouped around the ICD after it had been marked with colors. Photographs of the single dosimeters were taken for the purpose of easier classification of data (fig. 2). These measurements were taken as a base for calculating the radiation for the extended field. Later, a second TL measurement was carried out. This measurement was representative for the field reduction. Additionally, the patient underwent cardiologic checkups on a regular basis.
